**Technical Support Document  
For Record Of Decision  
Tin City, AFS**

February 29, 1988

INSTALLATION RESTORATION PROGRAM  
TECHNICAL SUPPORT DOCUMENT  
FOR RECORD OF DECISION  
TIN CITY AIR FORCE STATION  
LRRS SITE

Woodward-Clyde Consultants

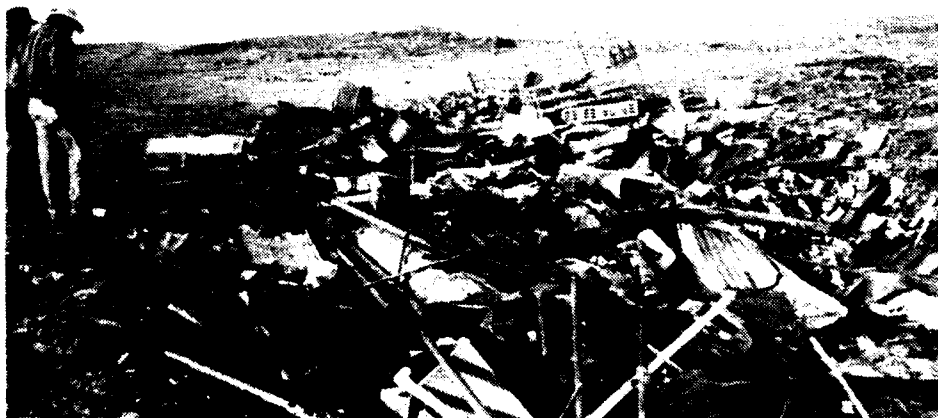
Current Landfill  
Tin City AFB

Sites visited at Tin City AFS (Table 2) include an abandoned dump and a spill/leak area at the Lower Camp (Sites 1 and 6), an active landfill (Figure 3), an abandoned dump, a waste accumulation area, and an area of runway oiling, all located at the Lower Camp (Sites 2, 3, 4, and 8, respectively). The White Alice Station and a nearby spill/leak area were investigated (Sites 5 and 7). An additional dump site (Site 9) located along the road about midway between the Upper and Lower Camps was also visited. However, this is not a site that was addressed in the Phase I report (Eng. Sci. 1985).

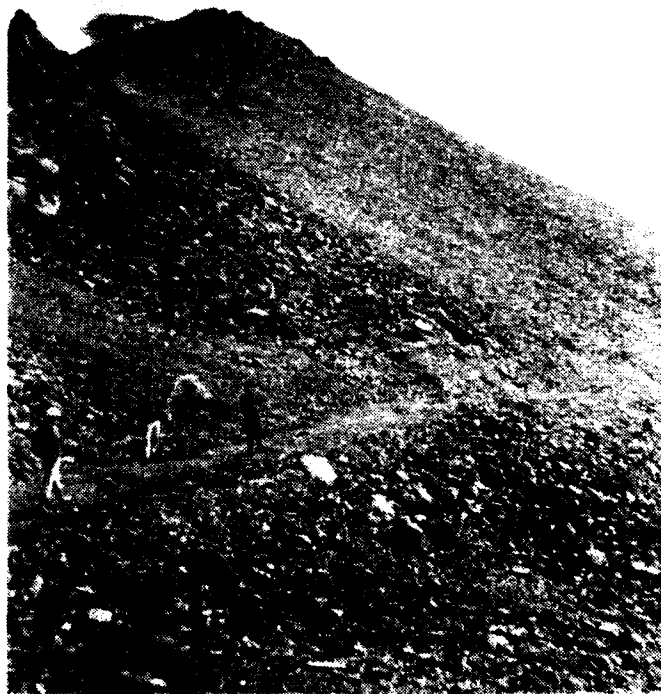
Upper Camp Dump  
Tin City AFB

The Upper Camp dump area (Site 1) is situated on a steep slope subject to high winds and severe weather (Figure 4). No debris or signs of contamination were observed by the field team. It is likely that any debris noted during Phase I investigations has since been blown from the site. There was no evidence of contamination remaining at spill/leak No. 2 (Site 6) also located at the Lower Camp. The area is barren and rocky.

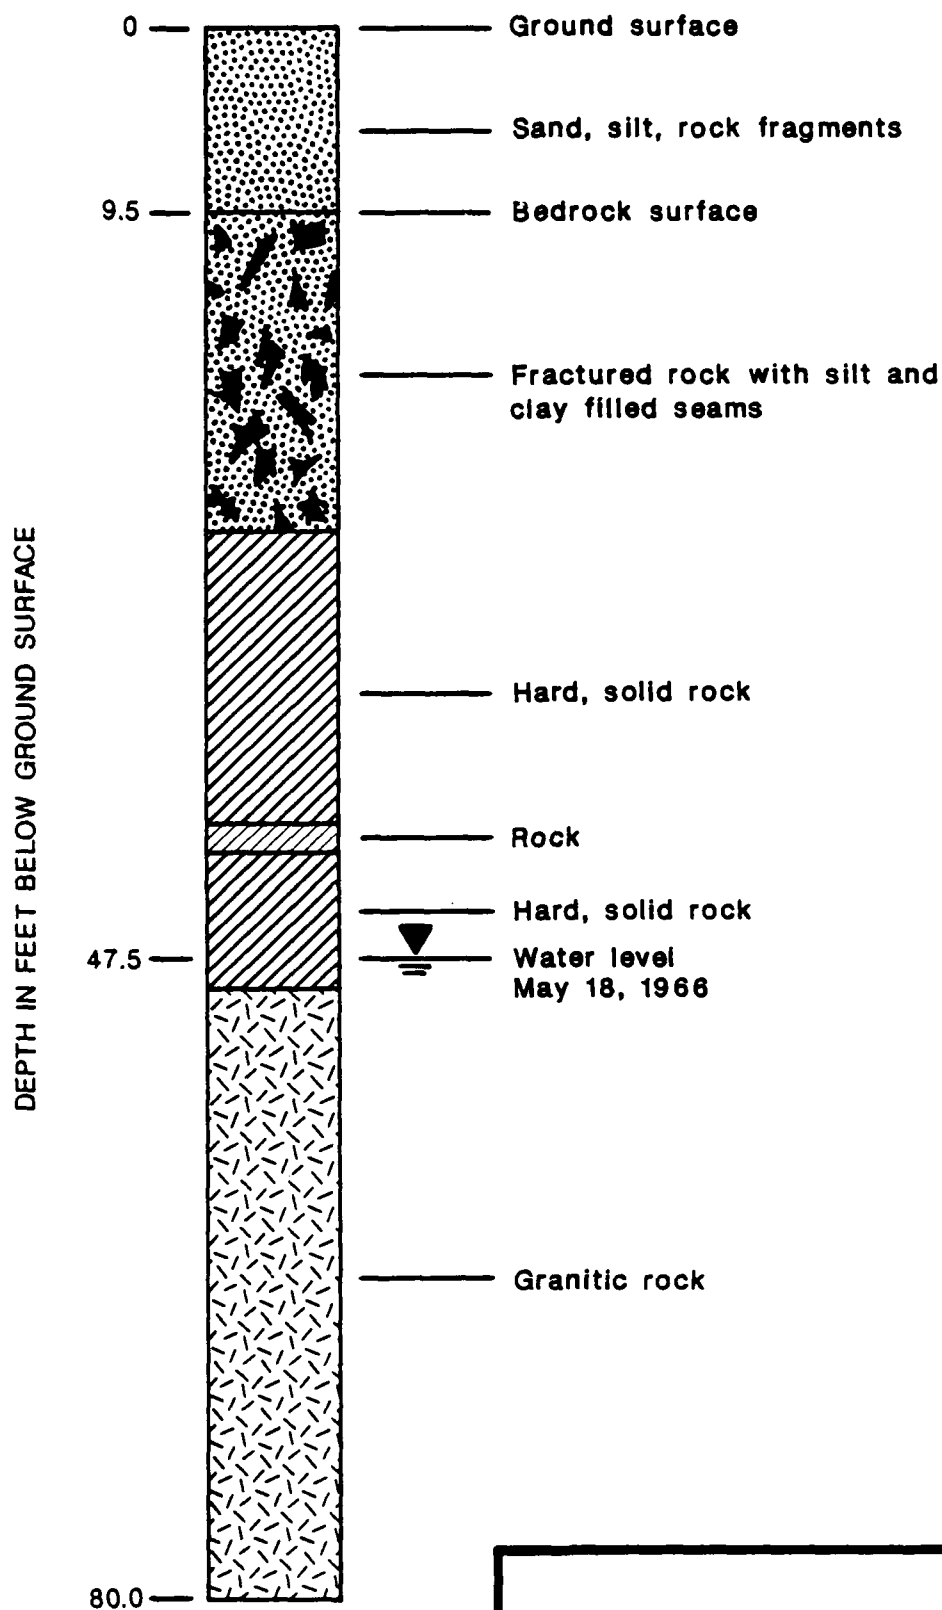
TIN CITY AFS  
WELL LOG

El. 352 Feet (Approx.)

Source: Modified from U.S. Geological Survey  
Water Resources Division File Data,  
undated.

The installation water supply consists of one supply well and a gallery. The well has been installed into fractured zones of granitic bedrock. The gallery has been constructed to intercept ground water flowing along a fault zone. Water is pumped from the well and gallery into storage tanks to be used by the installation (Eng. Sci. 1985, C. Humphry 1988). The water supply for the installation is located either upgradient or away from the six potentially hazardous sites at Tin City. Additionally, since the continental divide separates the installation from the settlement of Wales, the Wales drinking water supply cannot be impacted by the Tin City sites.

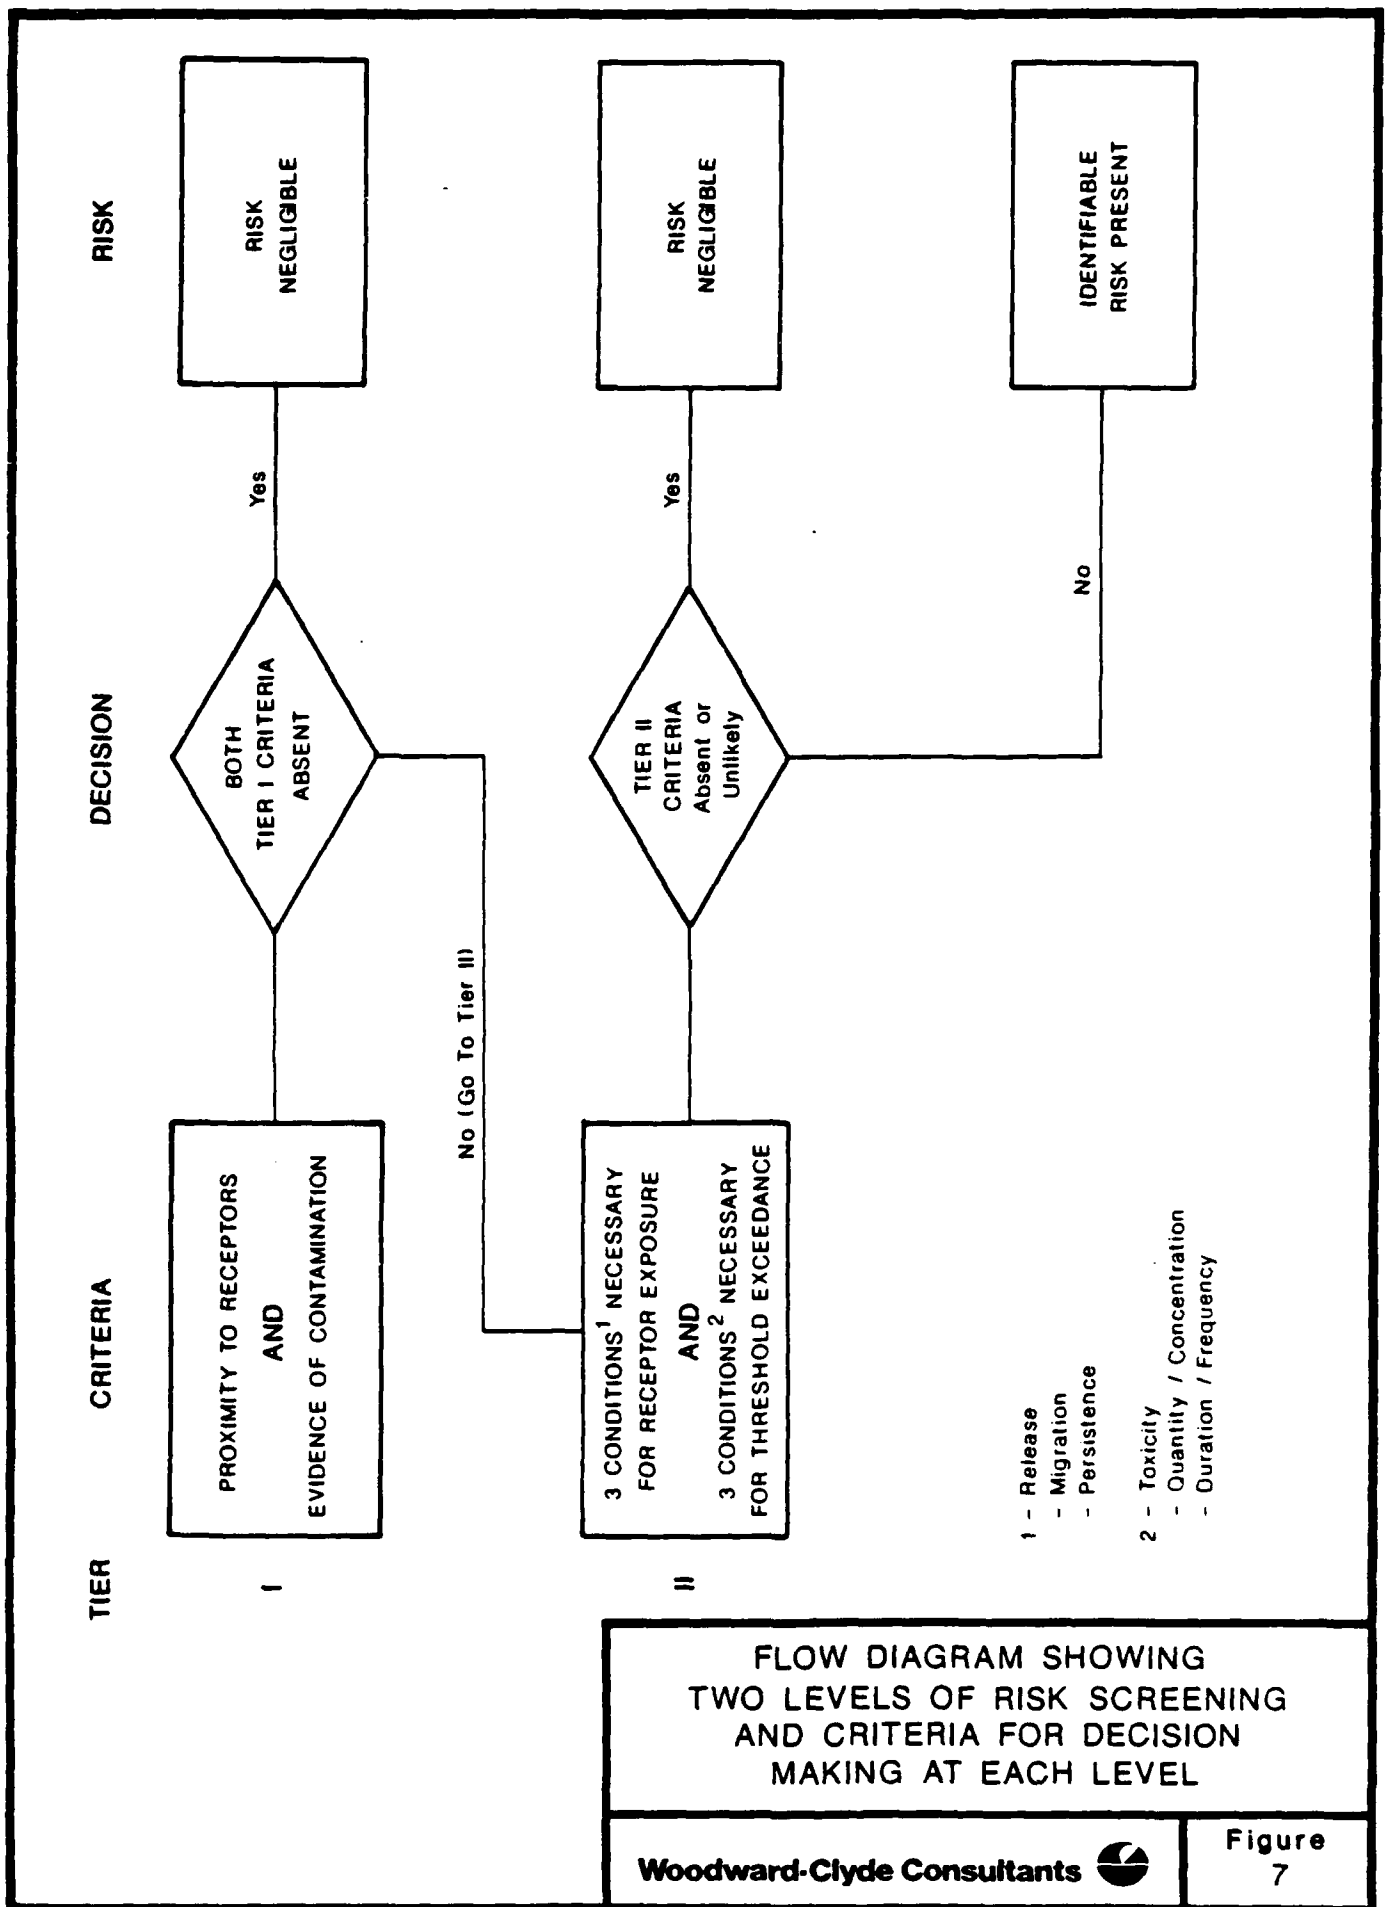
For the purposes of assigning risk levels to a site, a two-tiered hierarchical decision scheme is employed (see Figure 7). At tier I, an initial screening of the presence of contaminants and the proximity of sensitive receptors is made. This determination is made by reviewing historical records, observations from the site visit, or other evidence. If the available evidence does not indicate that contaminants have been released at the site and if the site is not close to sensitive receptors, then the probability of risk is considered negligible. In this case, a no further action alternative will be recommended. However, if it is concluded that the site is, or possibly has been, contaminated with hazardous or toxic substances, or if the site is in close proximity to sensitive receptors, then screening proceeds to tier II. The approach to tier II is deductive. First, receptors and the conditions necessary for exposure must be identified. Second, the conditions necessary for exceedences of thresholds must be established. Then, the actual conditions at the site are compared to the specified conditions. In actuality, all the specified conditions must

be present for significant risk to exist. However, the risk screening procedure used here is conservative in that it assumes a negligible risk only if all the conditions are absent. If all the necessary conditions are absent, then a negligible risk is clearly deduced. Likewise, if the status of a specified condition cannot be determined at a site but there is no reason to suspect that it exists, and all other conditions are absent, the site will be assumed to have negligible risk. If one or more of the conditions are present or suspected, then the site represents some identifiable level of risk.
